FRONT ELEVATION

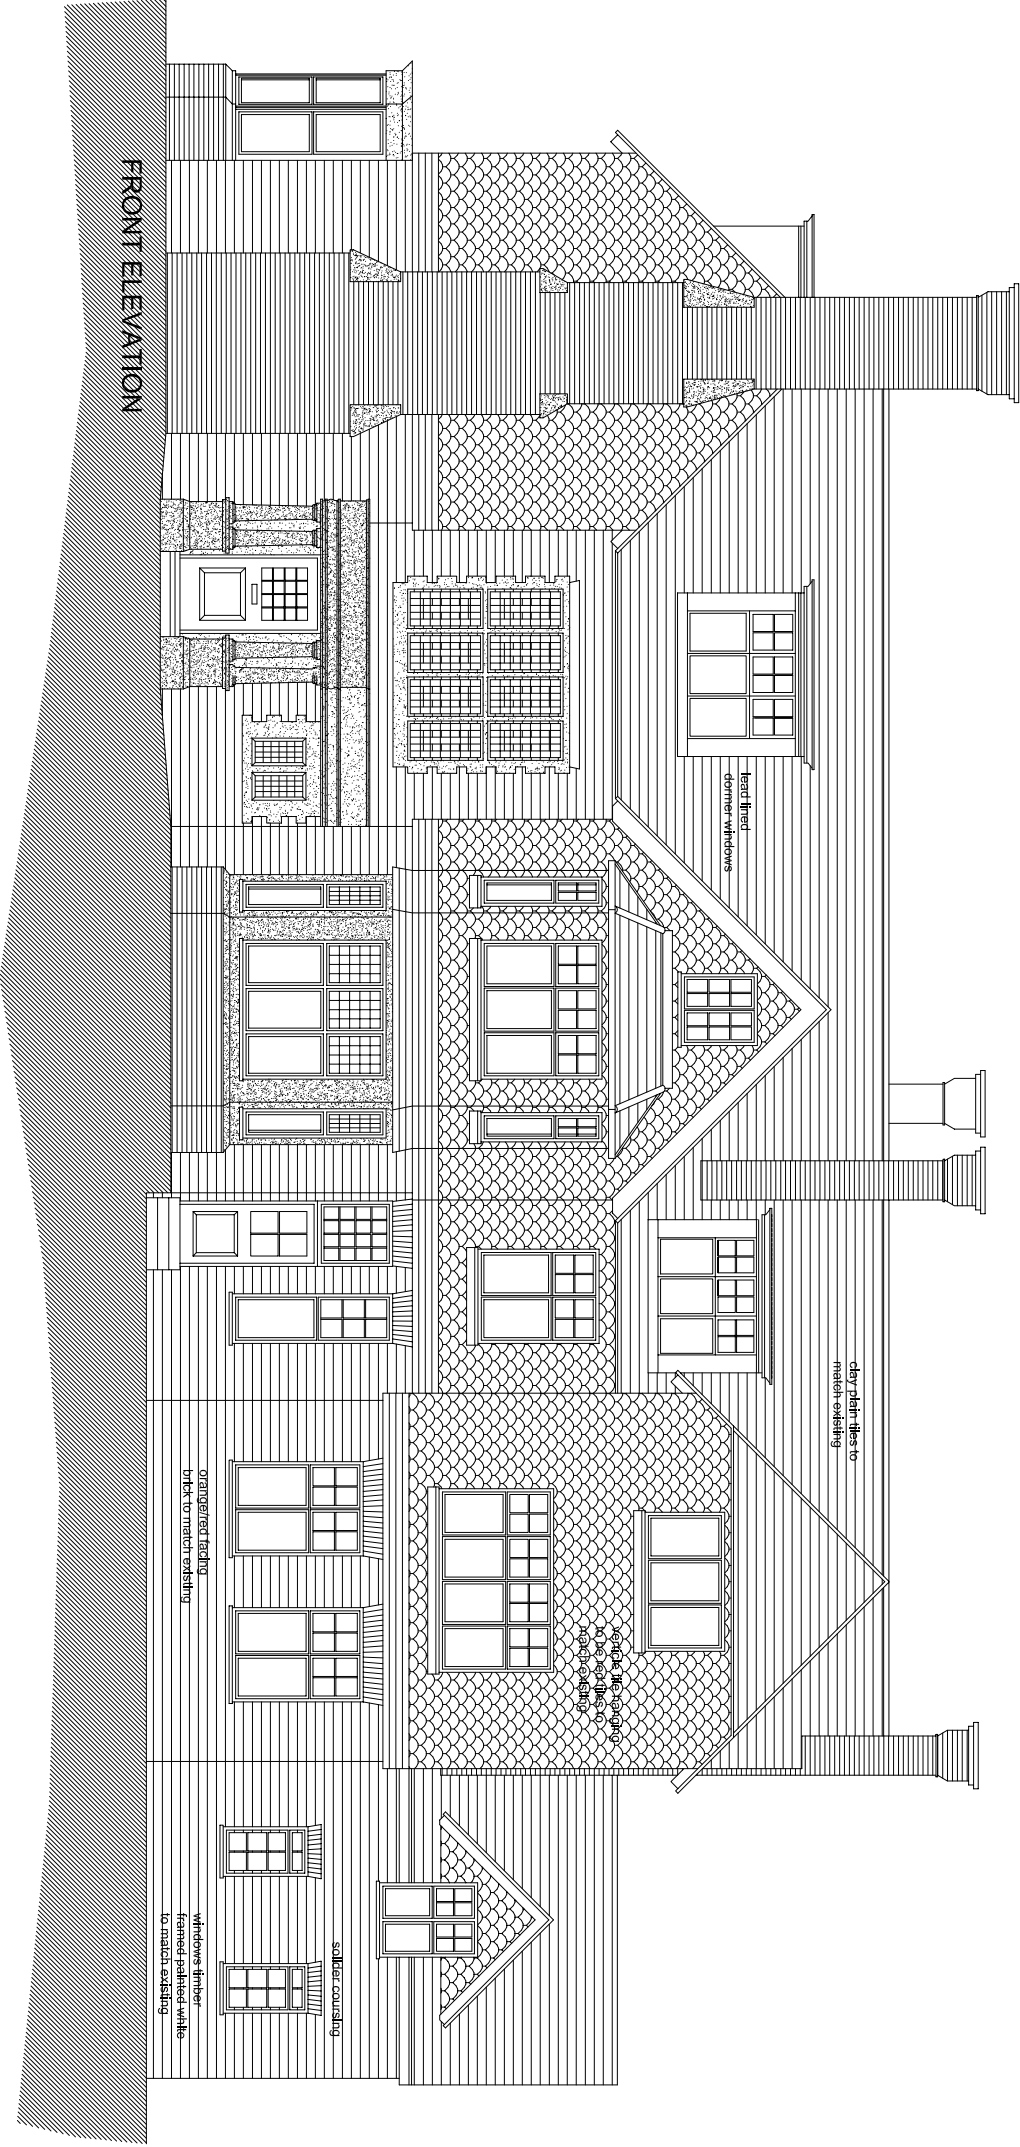
lead lined  
dormer windows

clay plain tiles to  
match existing

weathering  
to be repaired to  
match existing

orange/red facing  
brick to match existing

solid oak casing

windows timber  
framed painted white  
to match existing
